# DetaClad™ Characterization for High-Temperature and High-Pressure Hydrogen Service

**PVP2022-80639**

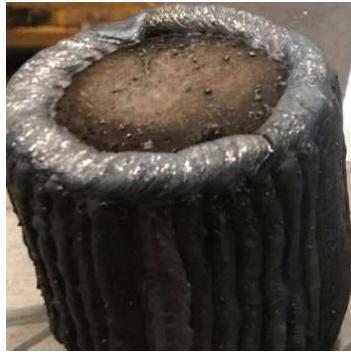
**Figure 4:** ASTM G146 Specimen Weld Overlaid on the Edge

The sides of cylinders were cladded to prevent hydrogen from escaping. To accomplish this cladding, gas metal arc welding (GMAW), was employed to WOL the coupon blanks and put a top seal between the EXW and the sides as shown in Figure 4.

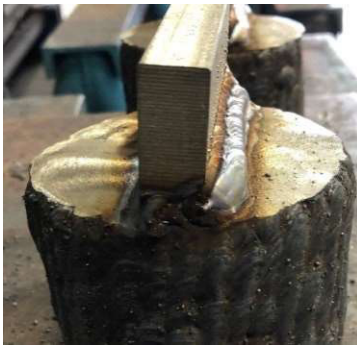
Additionally, a Type AISI 304 attachment was welded to 2 of the ASTM G146 coupons using gas tungsten arc welding (GTAW) root passes and subsequent GMAW passes. The purpose of that configuration was to validate the DirectAttach™ as shown in Figure 5. [To learn more about DirectAttach™ click here.](#) The bar was then removed to comply with specimen design Figure 3 before testing.

**Figure 5:** ASTM G146 Specimen for DirectAttach™
